ROGUE RIVER ESTUARY

Strategic Plan

2015

Prepared by Kelly Timchak and Cindy Ricks Myers Lower Rogue Watershed Council

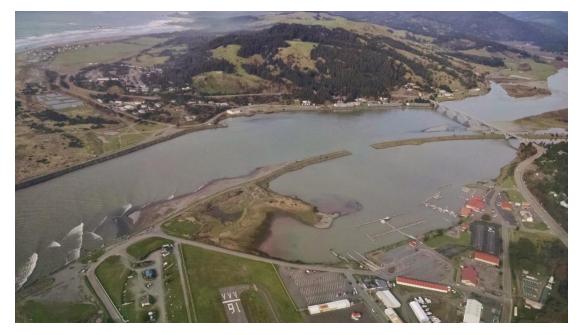
Rogue River Boat Basin. Photo credit: Kelly Timchak, 2015

Historically, the Boat Basin was a shallow subtidal and intertidal area with unrestricted circulation. The southern margin has been extensively riprapped and there are several boat moorages. Jerry's Rogue Jet Boats, located inside the Boat Basin, has been making regular trips up the river from the estuary since 1958. Other developments in the estuary waterway include the U.S. Highway 101 bridge abutments, two gravel removal operations and several boat docks, which are removed before winter flows. The northern shore has also been extensively riprapped and there are several boat moorages as well.

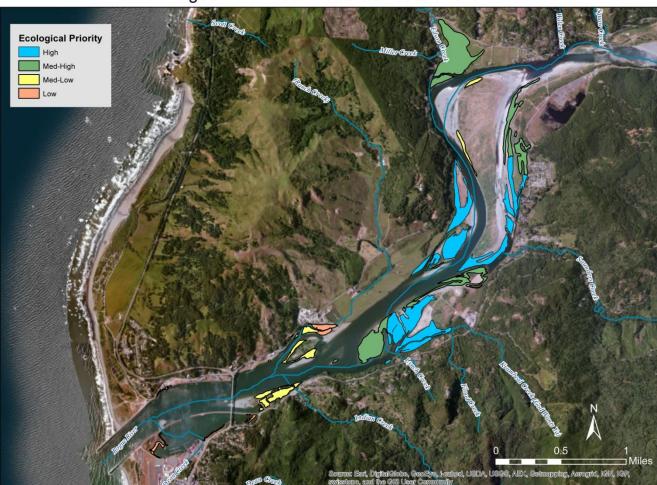
Figure 3: Rogue River Tidal Wetland Priority Map (larger map on page 38)

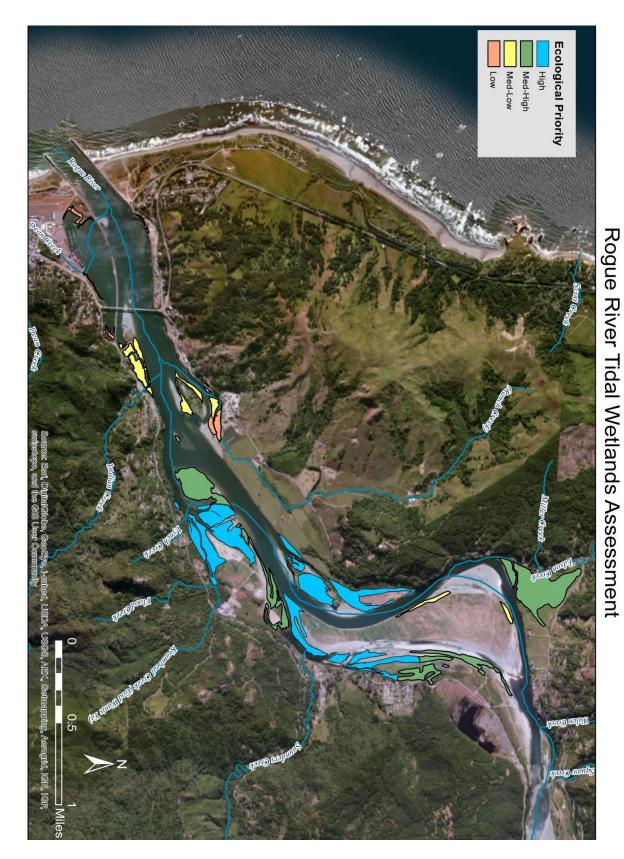
Figure 3: Rogue River Tidal Wetland Priority Map
