# **PORT ORFORD**

## **WATERSHED ASSESSMENT**

The Port Orford Watershed Council

June 2001

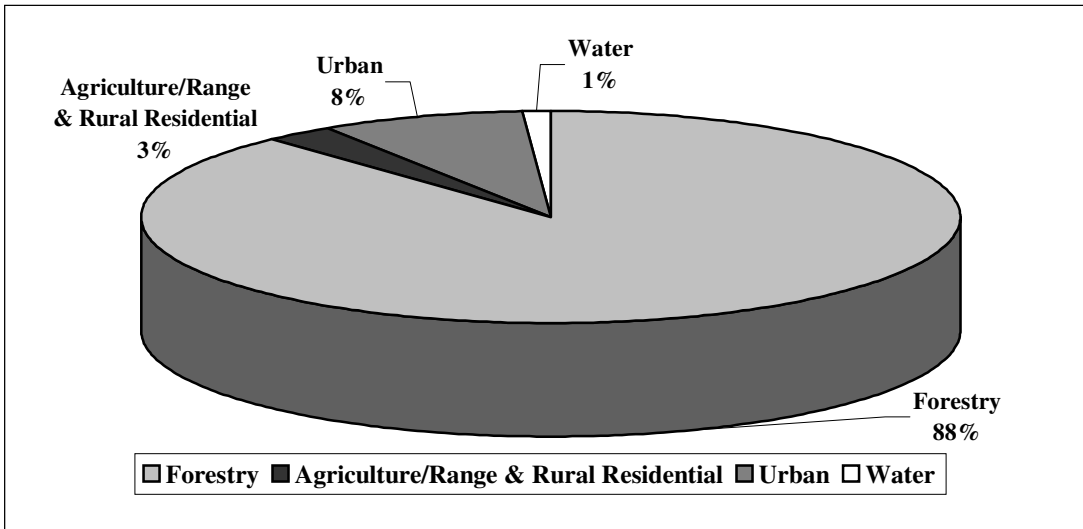
**Figure 1 Watershed Land Use Summary**

(3) Urban areas in the Port Orford watersheds account for about 8% of the total area, all of which is situated within the Garrison Lake watershed. Due to the limitations of this assessment, all agricultural areas within the Garrison Lake watershed were considered urban.

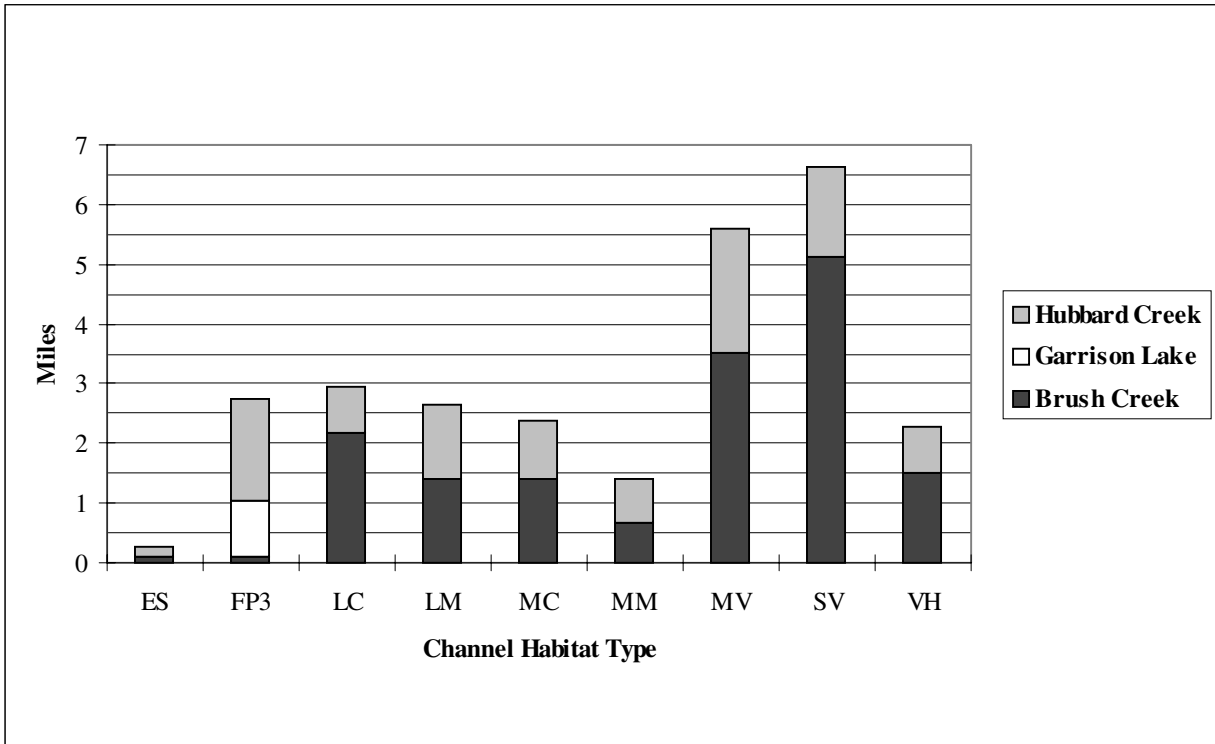
**Figure 2 Miles of Channel Habitat Types by Subwatershed**

Subwatershed	Channel Habitat Types									Totals
	ES	FP3	LC	LM	MC	MM	MV	SV	VH	
Brush Creek	0.1	0.1	2.2	1.4	1.4	0.7	3.5	5.1	1.5	16.0
Garrison Lake	0.0	0.9	0.0	0.0	0.0	0.0	0.0	0.0	0.0	0.9
Hubbard Creek	0.2	1.7	0.8	1.2	0.9	0.8	2.1	1.5	0.8	9.9
<b>Totals</b>	0.3	2.7	2.9	2.7	2.4	1.4	5.6	6.6	2.3	26.9
